# Continuous Design

(Tape Width)

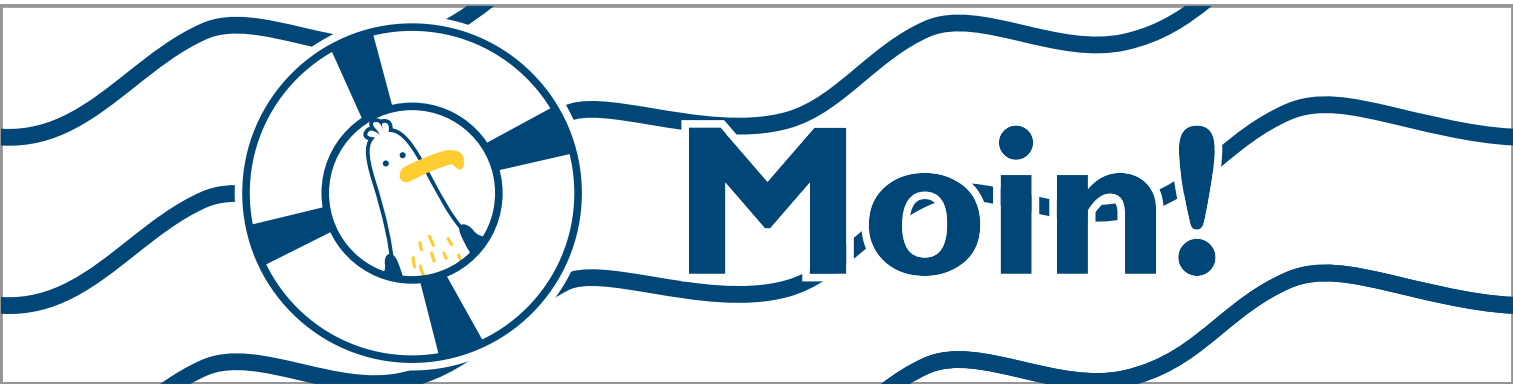
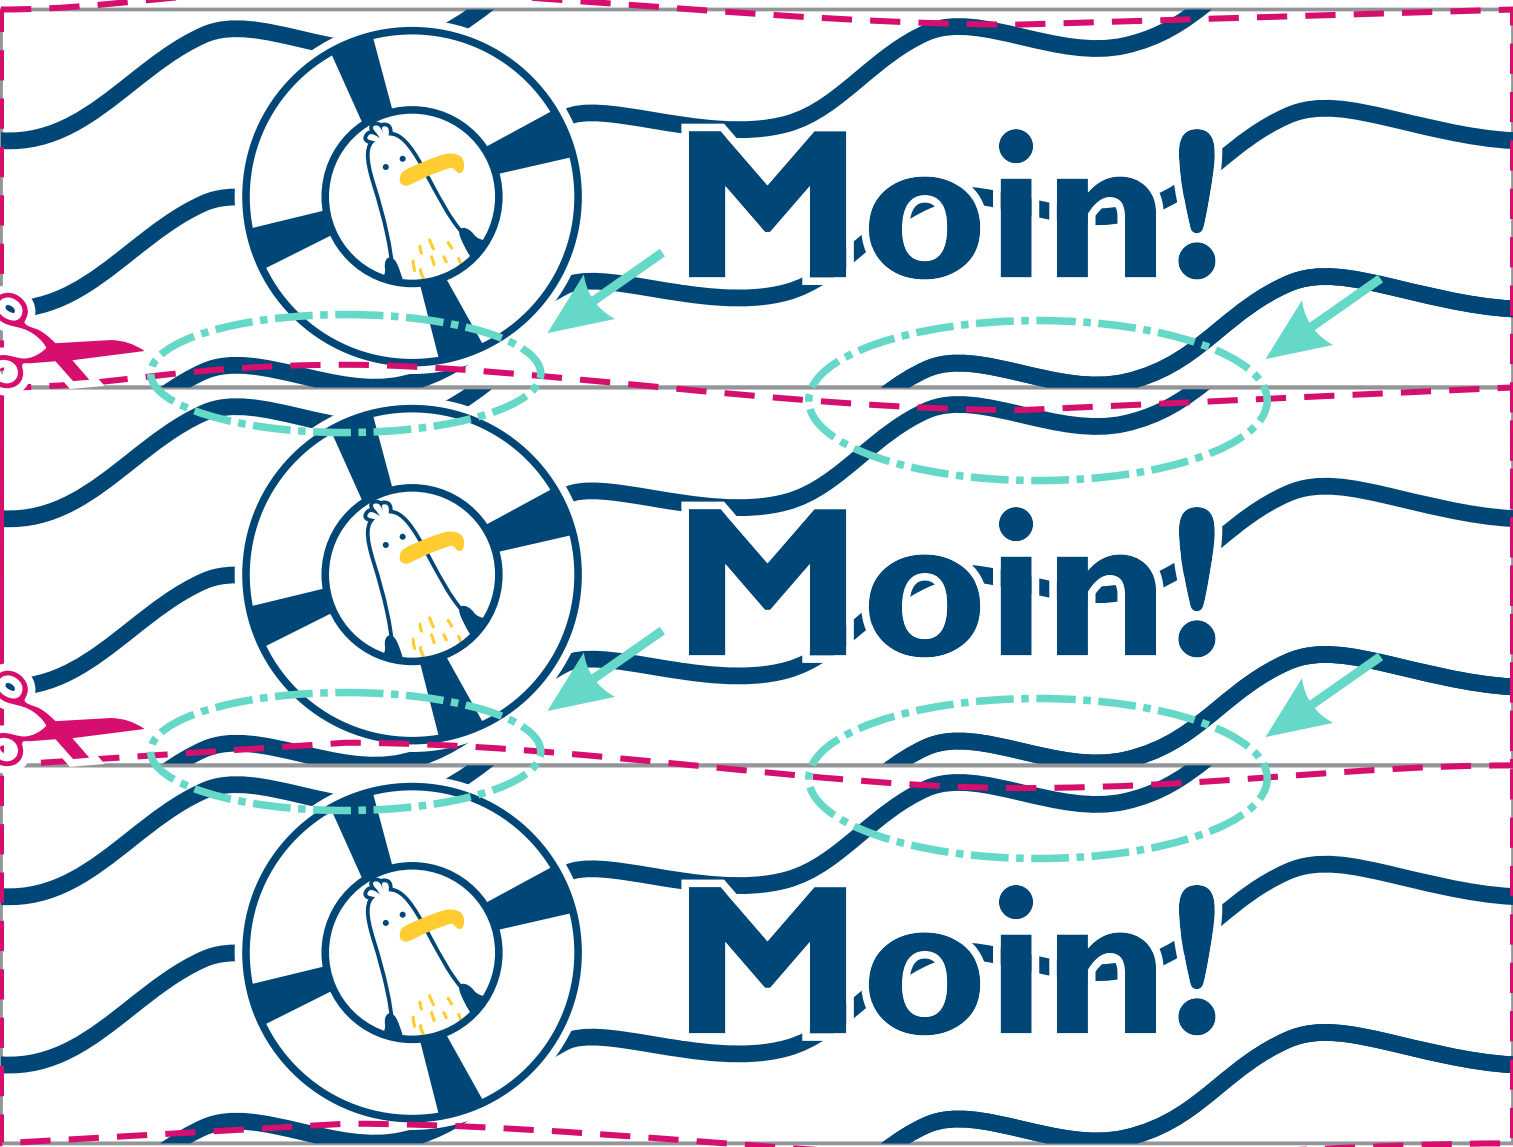
## Incorrect

Design extending to the tape edge (incorrect setup) = Issues during cutting

We work with continuous printing.  
Three tape strips are printed simultaneously and then cut apart.

During the cutting process, slight tape fluctuations can occur.  
*This illustration exaggerates the situation to demonstrate the issue more clearly.*

This can result in parts of one tape strip appearing on another (see arrow) if the print image is set up incorrectly.

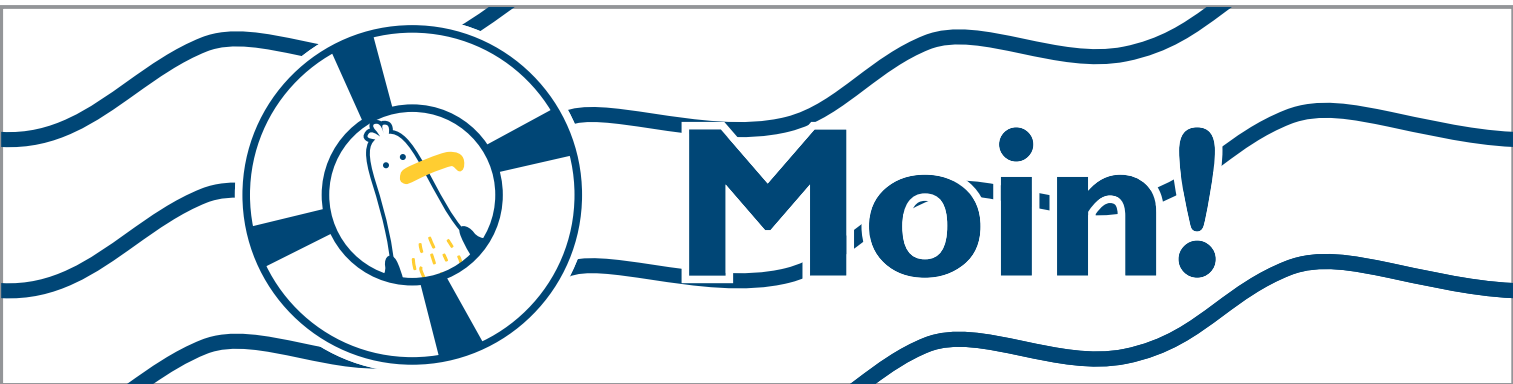
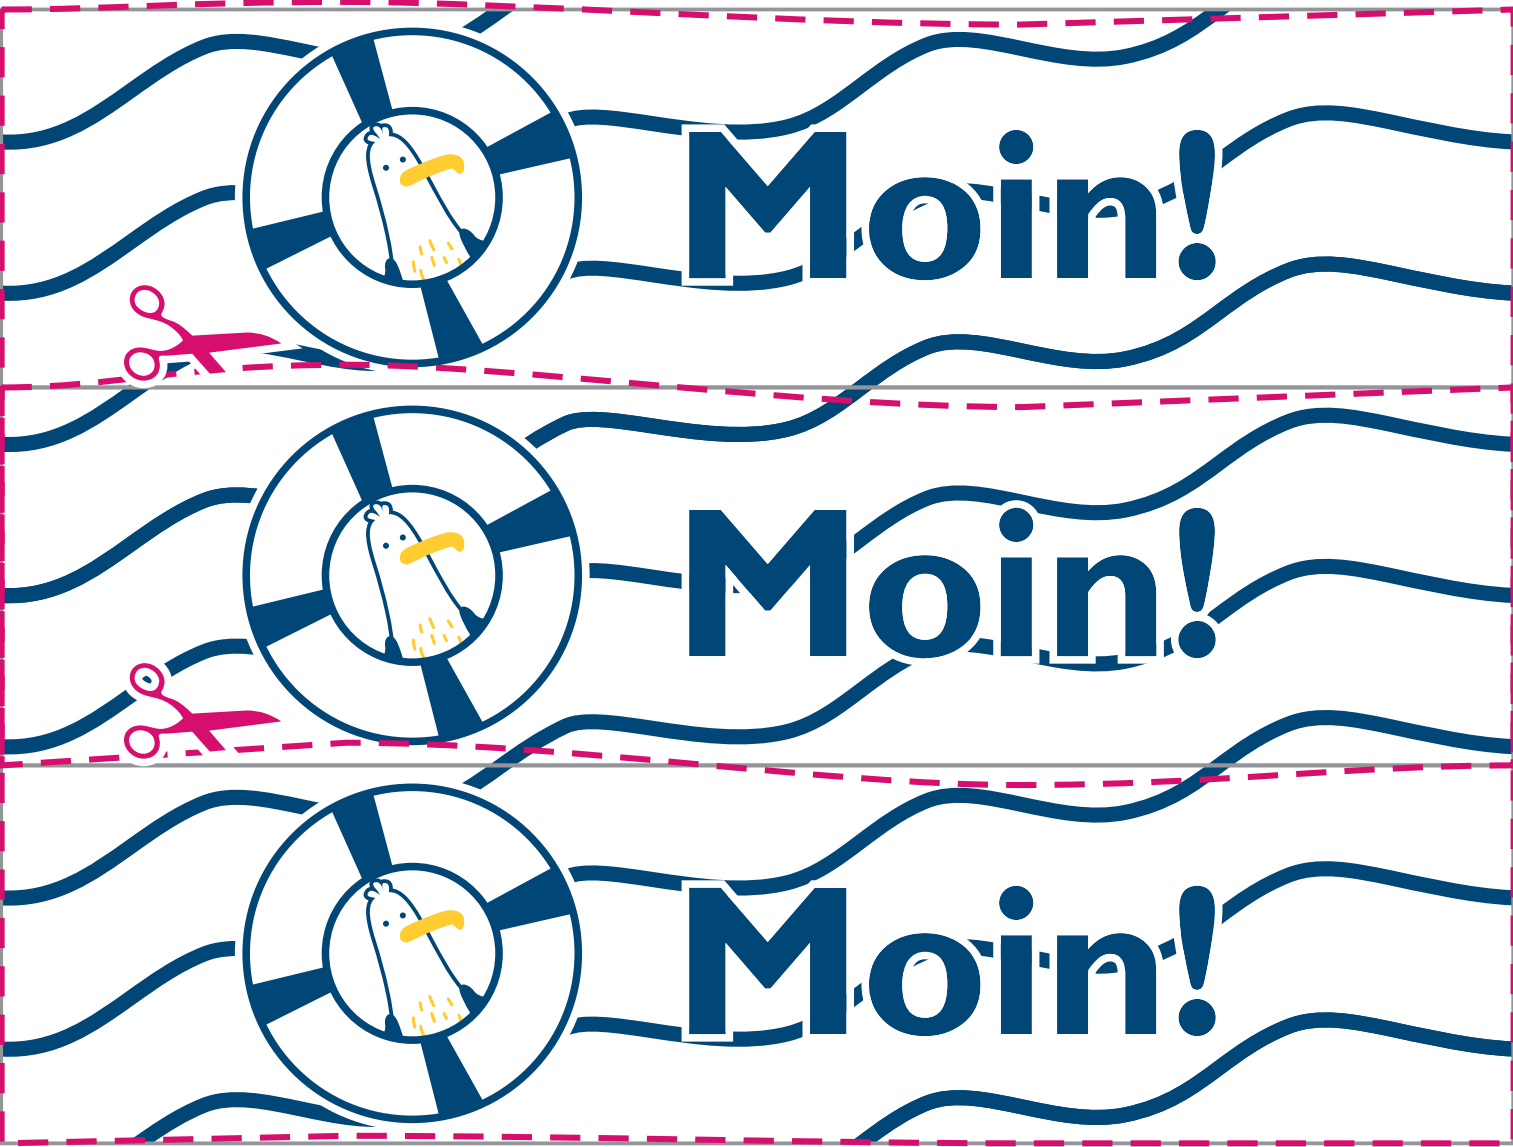
## Correct

Design extending to the tape edge (correct setup), Continuous design

The print image must be designed for scatter prints or edge-to-edge prints to be continuous across the entire material width (150 mm).
